District Report

Ramechhap

29 December 2017 – 4 January 2018

Housing Typology Report

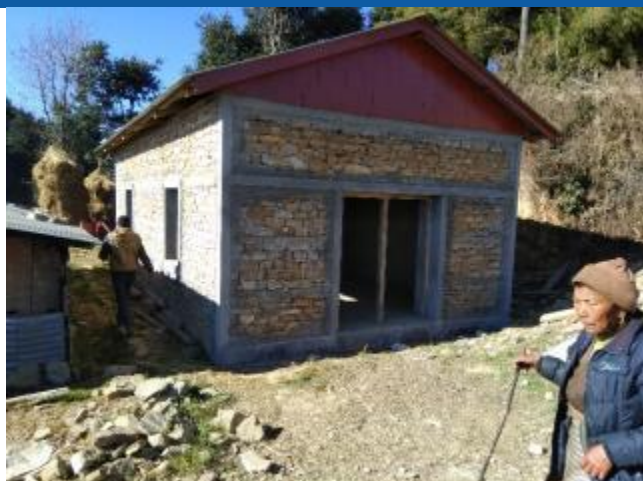
Caption: The house of Pemba Sherpa constructed in Umakunda Rural Municipality-4. The owner has received second tranche of reconstruction grant.

- ✓ RC Band Used.
- ✓ Light Gable wall.
- ✓ Light roofing materials.
- ✓ Stone in mud mortar.
- ✗ Excess opening in one face of wall.

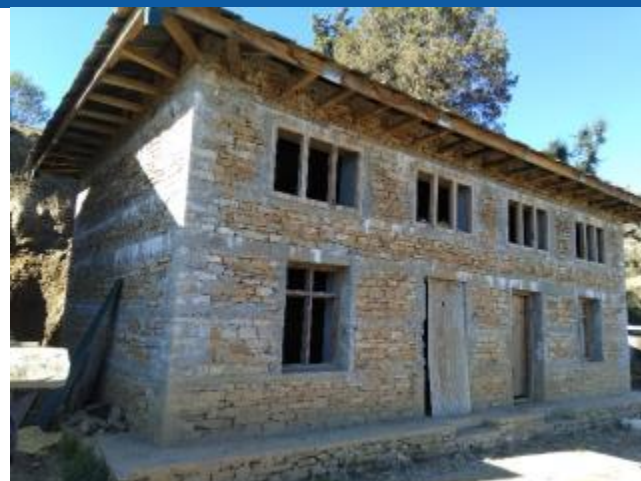
Caption: The house of Lakpa Chiri Sherpa constructed exclusive of Government grant constructed on Umakunda Rural Municipality-4.

- ✓ Stone in mud mortar
- ✓ RC Band Used
- ✗ Heavy roofing materials used without proper anchorage.
- ✗ Two floor constructed.

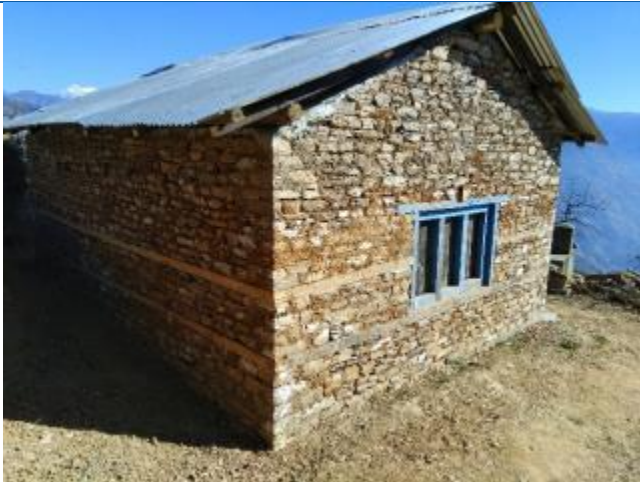
Caption: The house of Furba Sherpa being constructed in Umakunda Rural Municipality-4. He has received first tranche of reconstruction grant and has been forwarded for second tranche.

- ✓ Stone in mud mortar
- ✓ Wooden band used
- ✓ Light roofing materials
- ✗ Heavy Gable wall constructed without proper anchorage.
- ✗ Lintel band and roof band not constructed.

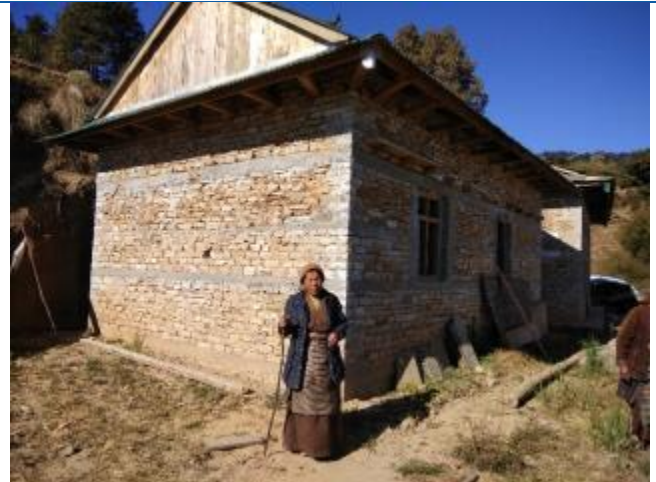
Caption: The house of Kandu Sherpa being constructed in Umakunda Rural Municipality-4. She has received second tranche of reconstruction grant.

- ✓ RC Band Used.
- ✓ Light Gable wall.
- ✓ Light roofing materials.
- ✓ Stone in mud mortar.
- ✓ One floor constructed.
