District Report

Ramechhap

15-21 December 2017

Housing Typology Report

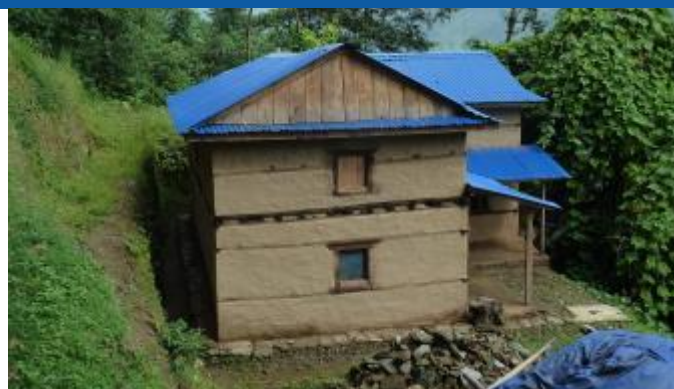
A noncompliance L shape building in Duragaun

- × Plinth level band missing and attic floor constructed with wooden band

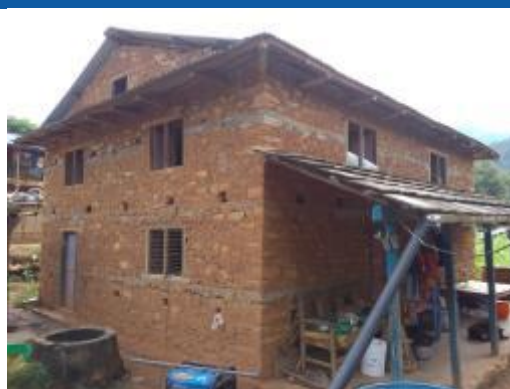
Caption: A noncompliance house in Chisapani, Manthali -8 of Adi Man Majhi which has received Recieved second Installment

- × Attic height greater than 3 feet
- ✓ RC band used
- × Gable wall constructed without gable band.

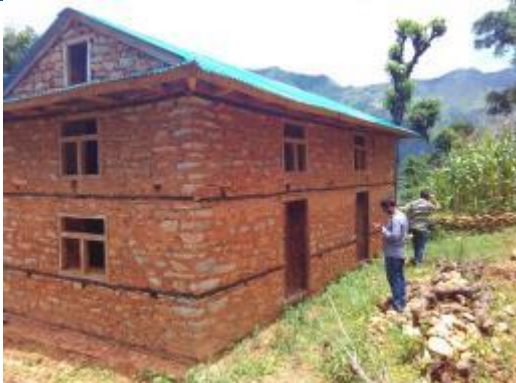
<p>Caption: A noncompliance house in Manthali -3, Kathjor constructed during initial phase of reconstruction without technical assistance.</p> <p>Key Features</p> <ul style="list-style-type: none"> ✓ Wooden band used × Improper positioning of bands × One attic on wooden band × Gable wall without band 	<p>Caption: A noncompliance house in Kathajor, Manthali -3 constructed immediately after earthquake without technical assistance</p> <p>Key Features</p> <ul style="list-style-type: none"> × One attic on wooden band × Gable wall without band × Horizontal and vertical bands missing

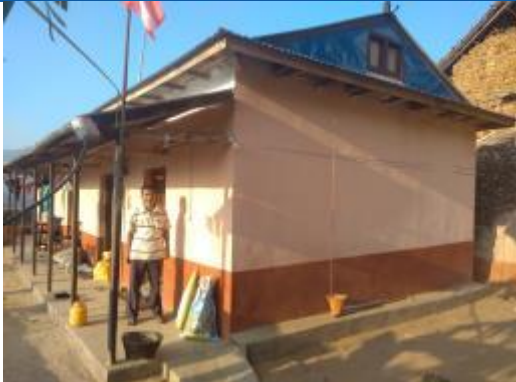
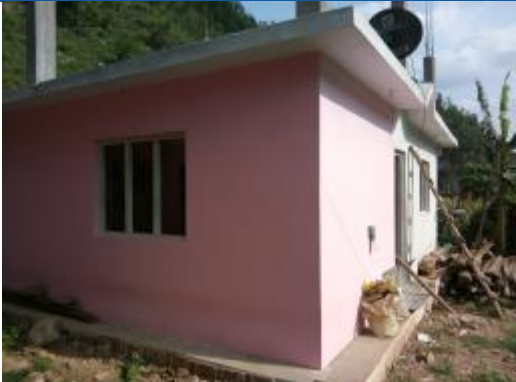
<p>Caption: The house of Raj Kumar Shrestha, the resident of Kathajor (Manthali -3) which have received second tranche of reconstruction grant. The technical assistance was provided by SDC-SW Nepal under Home owner Support Project.</p> <p>Key Features</p> <ul style="list-style-type: none"> ✓ RC bands used ✓ One plus attic ✓ Light gable walls used. <p>PC.: Mr. Jeevesh Karna , District Housing Co-ordinator, Homeowner Support Project, SDC-SW Nepal</p>	<p>Caption: The house of Bhakta Bahadur Baruwal, the resident of Khimti (Likhu RM-6) which have received second tranche of reconstruction grant. The technical assistance was provided by SDC-SW Nepal under Home owner Support Project</p> <p>Key Features</p> <ul style="list-style-type: none"> ✓ RC Frame Structure ✓ All Seismic elements present <p>PC.: Mr. Jeevesh Karna , District Housing Co-ordinator, Homeowner Support Project, SDC-SW Nepal</p>

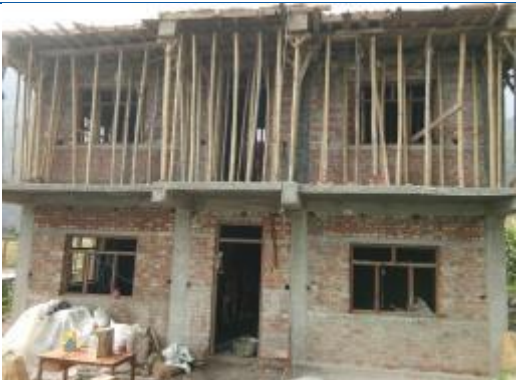
Caption: The house of Kamala Kadariya, the resident of Khimti (Likhu RM-6) which have received second tranche of reconstruction grant. The technical assistance was provided by SDC-SW Nepal under Home owner Support Project

- ✓ RC Frame Structure
- ✓ Structurally analysed by District Support Enginner and found structurally safe
- × One bay in one direction
- × Opening in front face ground floor
