# District Report

## Makwanpur

2 – 8 February 2018

## Field Visit Reports

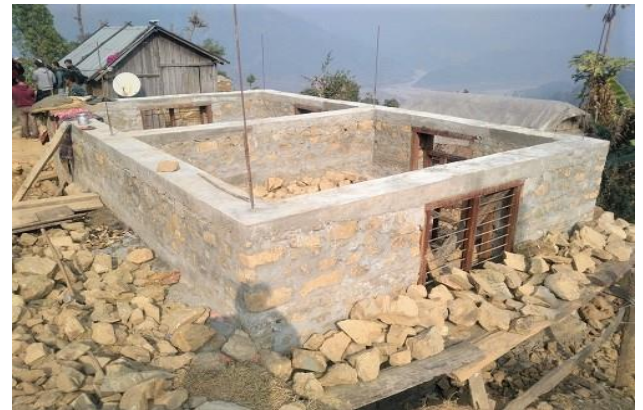
Figure 2: Manhari Rural Municipality, Makwanpur. House owner Shant Bahadur Thokar is made up stone in cement mortar. Under construction building, house owner has received 2<sup>nd</sup> tranche and processing for third tranche. Also he has constructed the toilet.

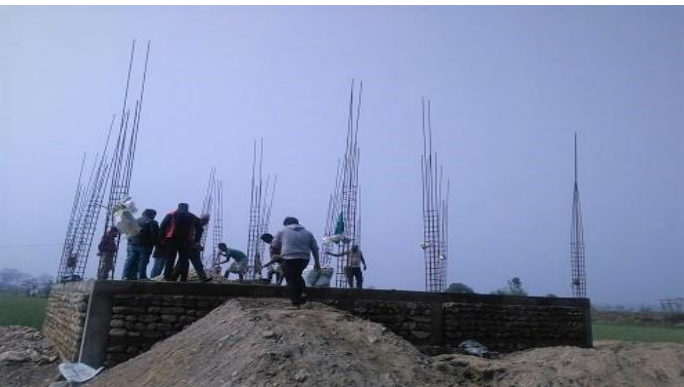
Figure 3: RCC frame structure, house owner is Khadak Man Shrestha. This building is in under construction and recommended for 2<sup>nd</sup> tranche by DLPIU field base engineer. location of this building is Manhari Rural Municipality-05.

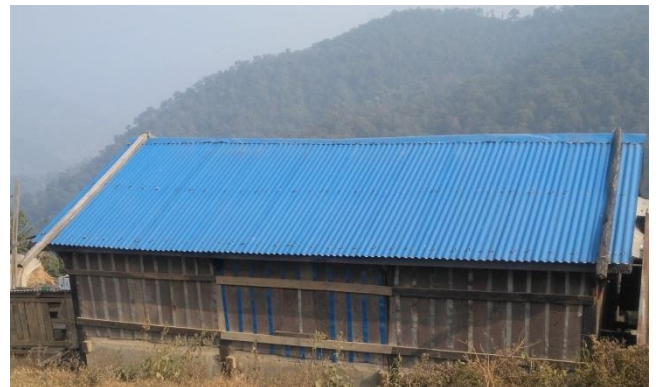
Figure 4: Hybrid structure, ground floor constructed with stone in mud mortar and first floor constructed with timber structure with flexible roof but this building was constructed without supervision of technicians and before 1years. it is non-compliance issues so DSE suggested for correction like as provide vertical post, to provide chicken mesh wire in band with required area. Also we regular flow up this noncompliance issues.
