# District Report

## Ramechhap

2 -8 February 2018

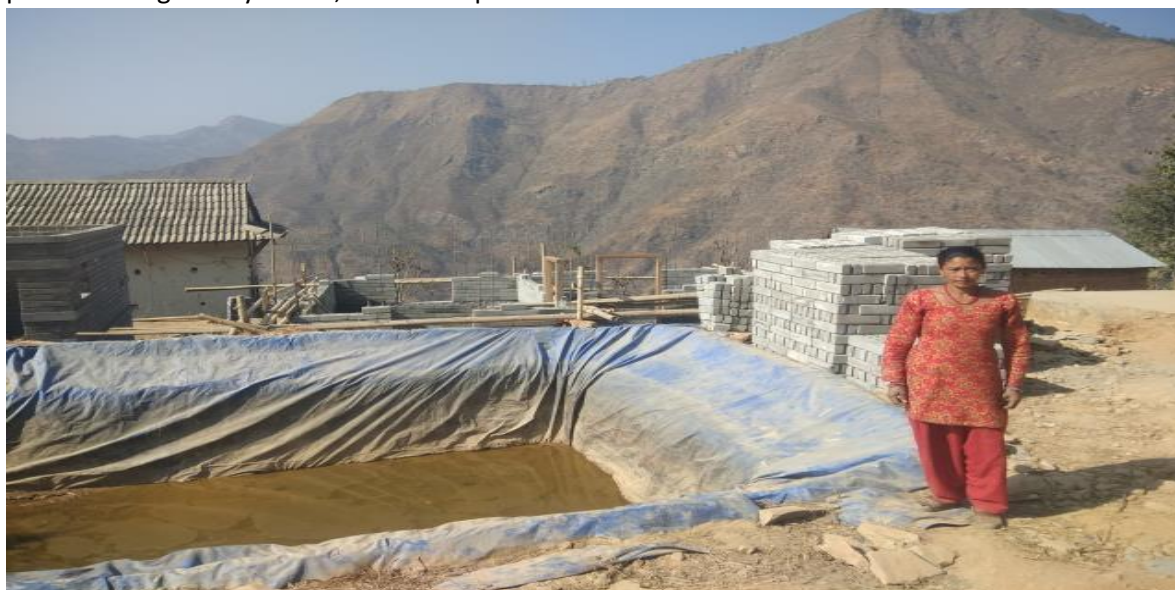
Figure 1. Sundari Shrestha with her plastic pond and her house being reconstructed on background

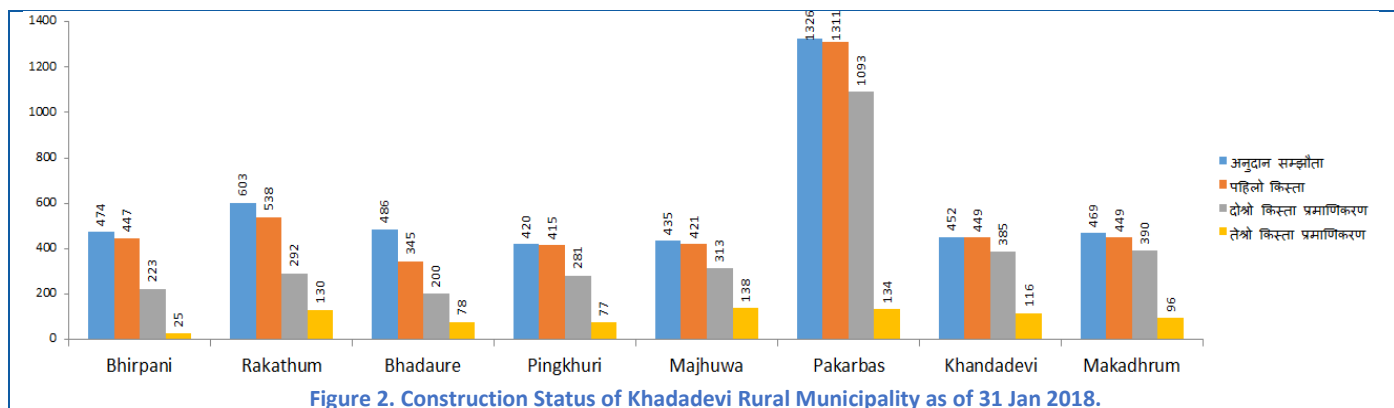
Date	Location	Participants
2 February 2018	Bhirpani, Khadadevi Rural Municipality	<ul style="list-style-type: none"> <li>Tulasi Ram Lamichhane, District Technical Coordinator and Janak Raj Joshi M&amp;E Consultant CLPIU</li> </ul>
<b>Objective(s)</b>	<ul style="list-style-type: none"> <li>To identify the causes for low construction rate in ward 3 of Khadadevi Rural Municipality despite of the rural municipality ranking two on the construction status in district.</li> <li>To collect necessary data regarding reconstruction and make peoples representatives informative regarding reconstruction.</li> <li>To observe the construction pattern adapted in the rural municipality.</li> </ul>	
<b>Summary</b>	Description of field visit (maximum 300 words)	
<p>Former Bhirpani VDC which lies in ward number 3 of Khadadevi Rural Municipality has the construction rate of 49.88 % as of 31 Jan 2018 which is the lowest of the Rural municipality with average construction rate of 72.62 of same date. The Rural Municipality exhibits the highest construction at Makadum with 86.85 % of construction rate. The comparative chart of construction rate in the rural municipality has been identified as:</p>

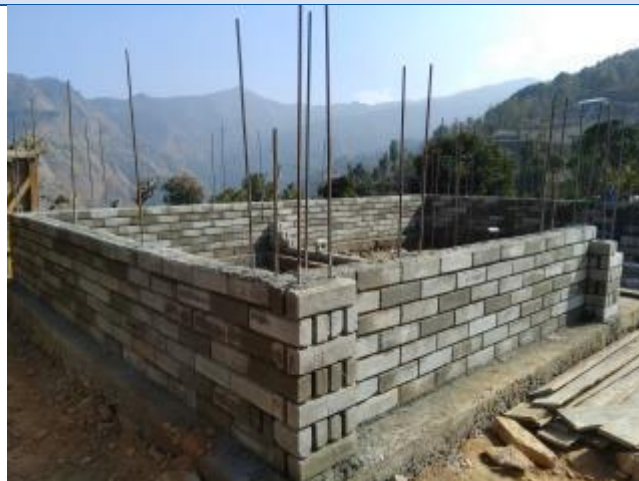
Caption: The two room structure of Garud Singh Tamang, resident of Hiledevi, Sunapati Rural Municipality-3 being constructed by using CSEB interlocking bricks. The blocks are produced by vendor in Mulot and have been constructing the earthquake resilient house at 6.5 Lakhs with free transportation within 10 km area. The house owner has received first tranche. Since he had constructed the plinth level after the Poush end deadline, he has not been verified for second tranche and not been able to receive the second tranche

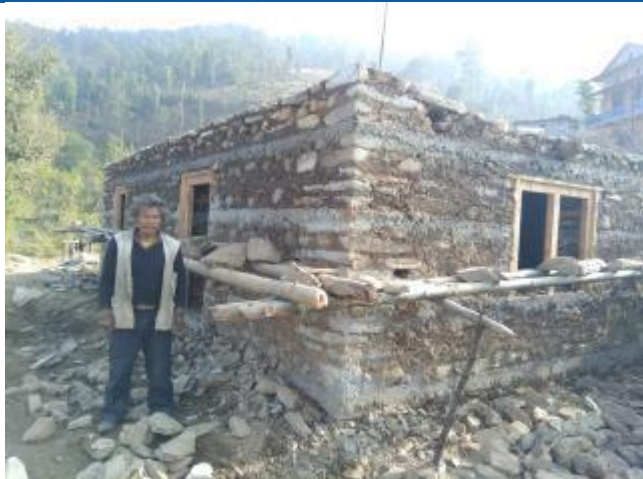
Caption: The two room structure of Brish Bahadur Tamang, resident of former Khadadevi VDC being constructed using stone in mud mortar. The RC Bands have been provided to the house as seismic parameters. He has received second tranche on first week of Asar 2074.

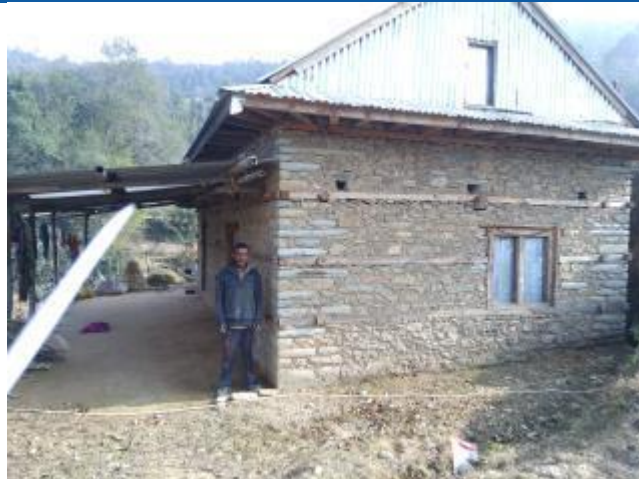
Caption: The constructed house of Chamar Singh Tamang, resident of ward number 7, Khadadevi, of Khadadevi Rural Municipality. The house is constructed using stone in cement mortar. The RC bands have been provided to the house. He has received third tranche of reconstruction grant on 24<sup>th</sup> Poush 2074. The house was completed in 6 lakhs

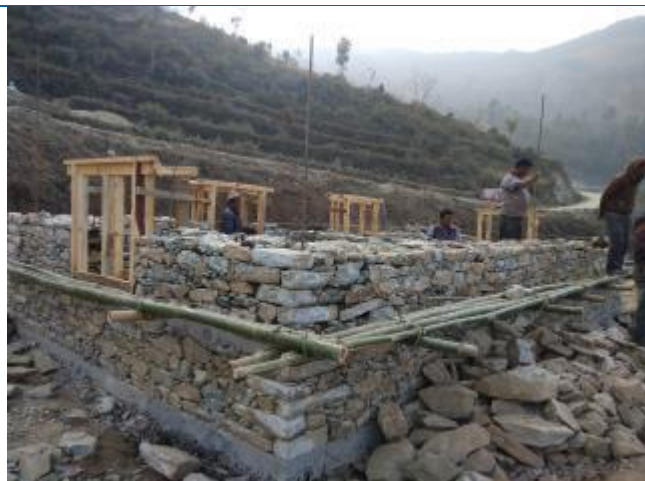
Caption: The house of Durga Bahadur Shrestha, resident of ward number 7, Khadadevi, Khadadevi Rural Municipality being constructed using stone in mud mortar. The RC Bands have been provided to the house. The owner has received the second tranche on magh and is expected to be completed by end of falgun.

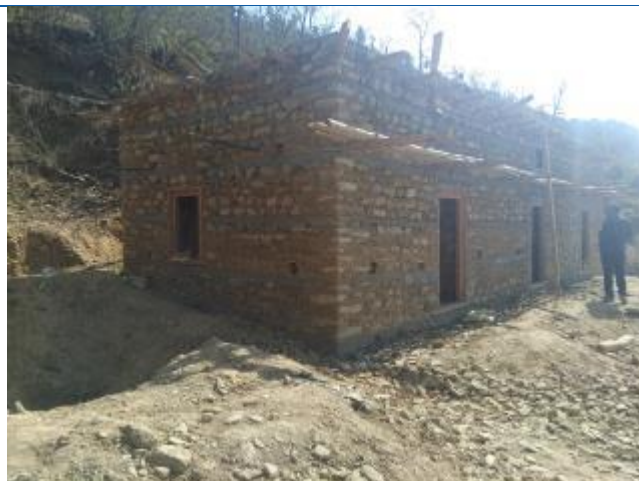
Caption: The three room house of Tek Bahadur Thapa, resident of ward number 3, Bhirpani, of Khadadevi Rural Municipality. The house is being constructed using stone in cement mortar. The RC bands have been provided to the house. He has received second tranche of reconstruction grant on 2<sup>nd</sup> Poush 2074. The house is expected to be completed in 8 lakhs.

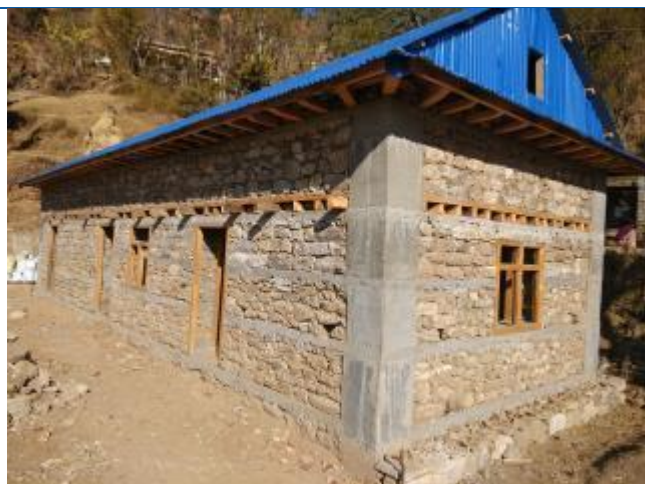
Caption: The three roomed house of Shankar Pandit, Tokarpur, of Doramba Rural Municipality. The house is being constructed using stone in cement mortar. The RC bands have been provided to the house. The RC columns have been provided on the corners. The file has been forwarded to District Support Engineer for the safety analysis.

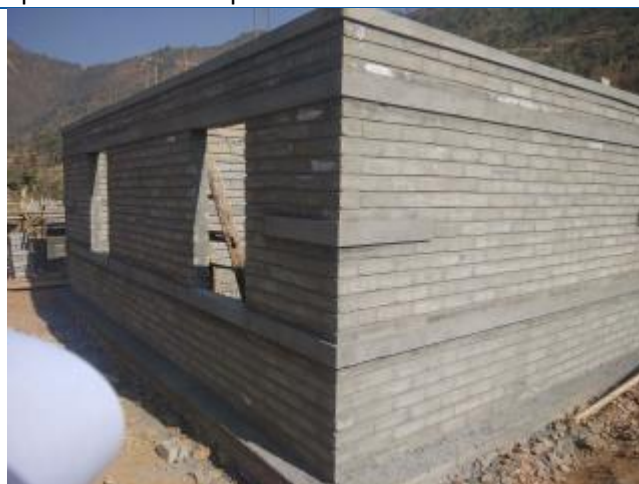
Caption: The two room structure of tranche Ram Bahadur Shrestha, resident of Bhirpani, Khadadevi Rural Municipality-3 being constructed by using CSEB interlocking bricks. The blocks are produced by vendor in Mulot and have been constructing the earthquake resilient house at 6.5 Lakhs. The house has been recommended for second tranche on Mangsir 2074 but has not received the tranche yet.

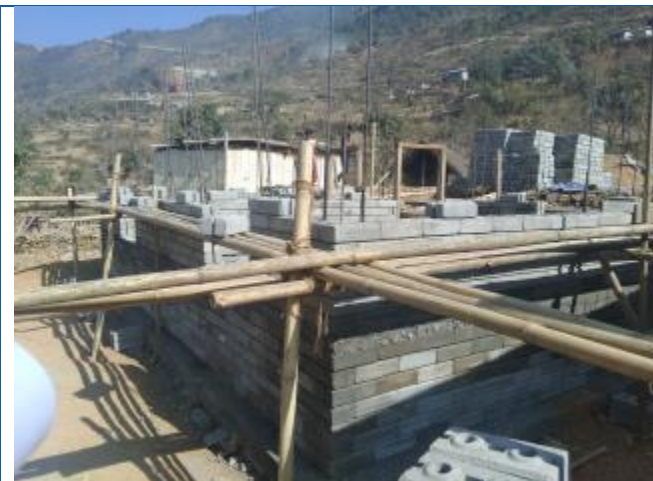
Caption: The two room structure of tranche Keshar Bahadur Shrestha, resident of Bhirpani, Khadadevi Rural Municipality-3 being constructed by using CSEB interlocking bricks. The blocks are produced by vendor in Mulot and have been constructing the earthquake resilient house at 6.5 Lakhs. The house has been recommended for second tranche on Poush 2074 and has not received the tranche yet.

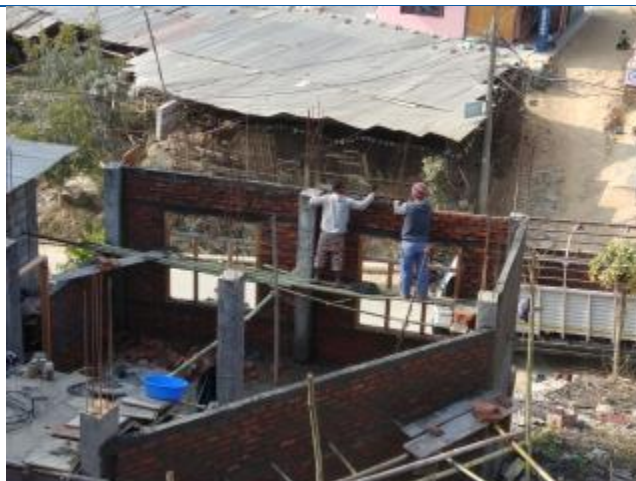
Caption: The RC frame house being constructed on Manthali Municipality has reinforcement missing on the horizontal Bands.
