# District Report

## Ramechhap

22-28 December 2017

## Housing Typology Report

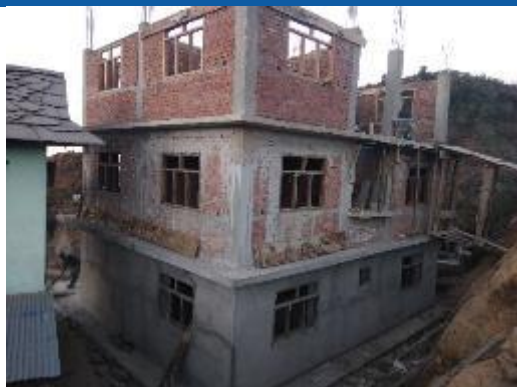
Caption: The house of Man Bahadur Khatri being constructed on Priti of Umakunda Rural Municipality.

- ✓ Seismic elements used.
- ✓ Right proportionate of seismic elements.
- ✗ Excess height of building.

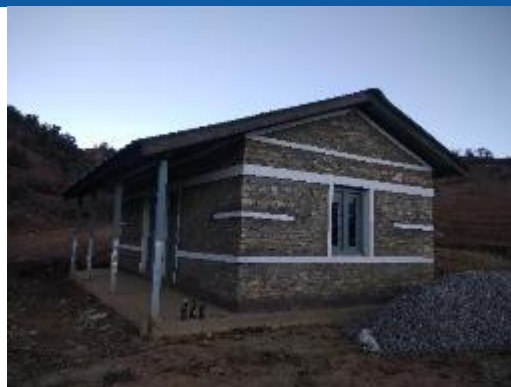
Caption: The model house constructed by GWS on Priti of Umakunda Rural Municipality.

- ✓ Stone in cement mortar
- ✓ RC Band Used
- ✓ Gable band provided
- ✓ One floor building

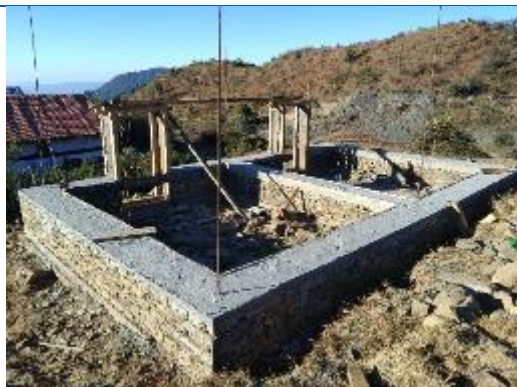
Caption: The house of Krishna Prasad Acharya being constructed on Priti. He have received first tranche of reconstruction grant and has been forwarded for second tranche.

- ✓ Stone in mud mortar
- ✓ RC Band used
- ✓ Vertical reinforcement used

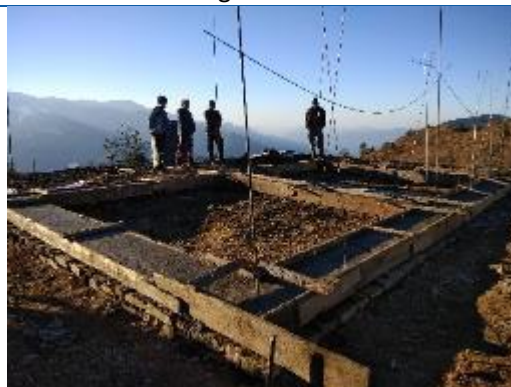
Caption: The house of Dhan Raj Lamichhane being constructed on Priti. He have received first tranche of reconstruction grant and has been waiting for the process for the second tranche by technical personnel.

- ✓ RC band used
- ✓ Vertical reinforcement used
