District Report

Ramechhap

11 – 25 May 2018

Housing Typology Report

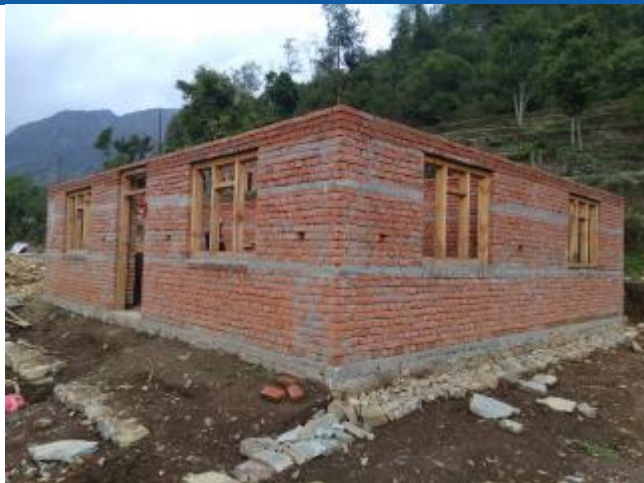
Caption: The house of Manmaya Magar of Dimipokhari, Sunapati Rural Municipality-2 being constructed. The house has been constructed using brick in cement mortar. The house consists of four rooms. The house has been provided with passage of 4'. The doors have been installed within 2' from the corners. The door and windows have not been provided at the same level. The owner has not received any tranches of reconstruction grant.

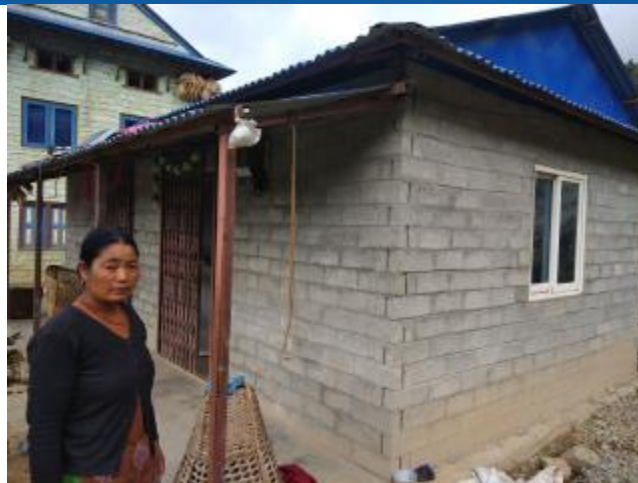
Caption: The house of Amrita Thapa Magar of Dimipokhari, Sunapati Rural Municipality-2 being constructed. The house has been constructed using interlocking blocks. The house has two rooms. The owner has received second tranche of reconstruction grant. The house has been constructed in 5 lakhs.

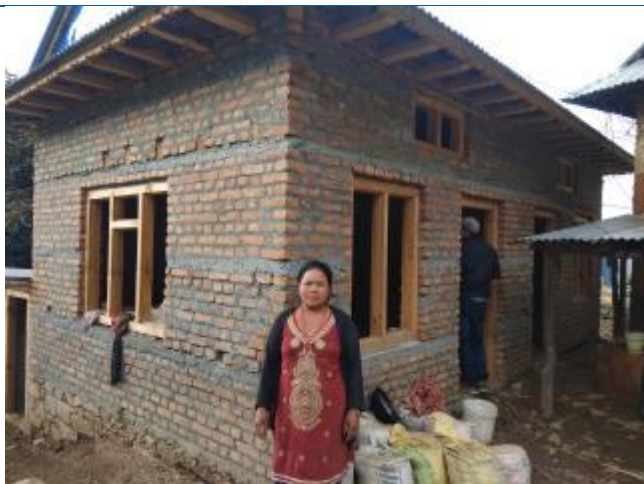
Caption: The house of Bhakta Laxmi Thapa Magar of Dimipokhari of Sunapati Rural municipality-2. The house has been constructed using brick in cement mortar. The house consists of two rooms. The owner has not received all three tranches of reconstruction grant.

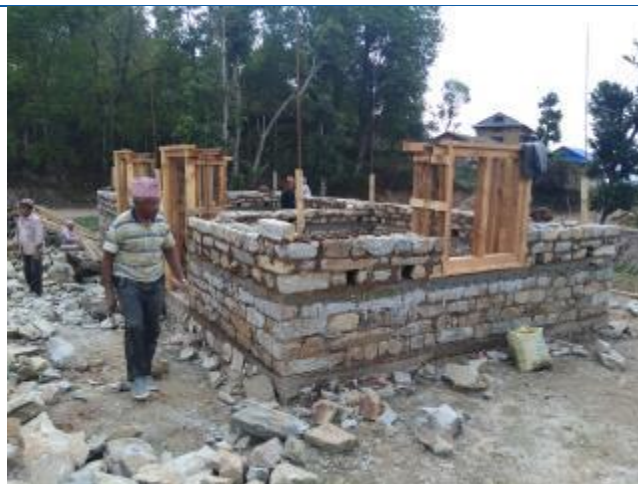
Caption: The house of Nar bahadur Magar of Dimipokhari of Sunapati Rural municipality-2. The house has been constructed using stone in mud mortar. RC band has been provided to the house. The house consists of two rooms. The owner has received second tranche of reconstruction grant.

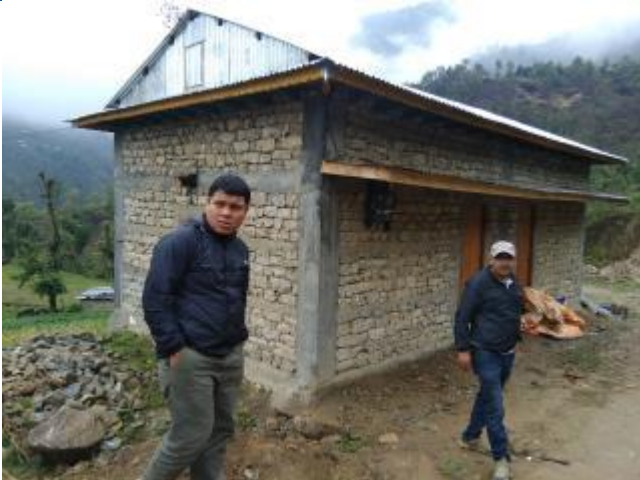
Caption: The house of Salam Tamang of Doramba of Doramba Rural municipality. The house has been constructed using stone in mud mortar. RC band has been provided to the house. The house consists of two rooms. Columns have been provided to the building at the corner. The owner has received second tranche of reconstruction grant.

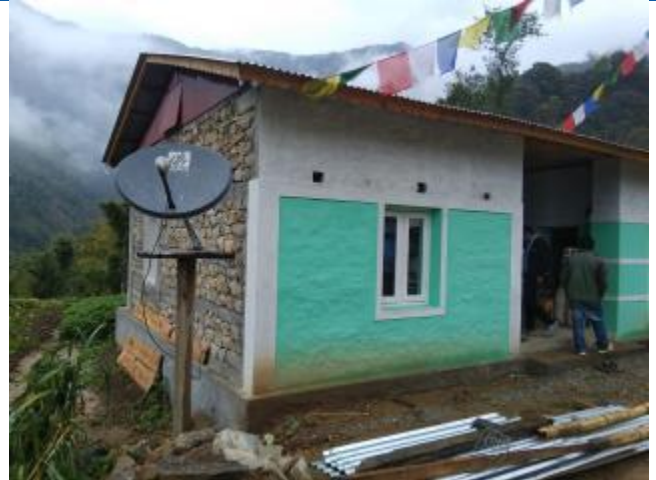
Caption: The house of Kale Tamang of Doramba of Doramba Rural municipality. The house has been constructed using stone in mud mortar. RC band has been provided to the house. The house consists of three rooms. The owner has received second tranche of reconstruction grant and have been forwarded for third tranche.
