District Report

Makwanpur

23 - 29 March 2018

Field Visit Reports

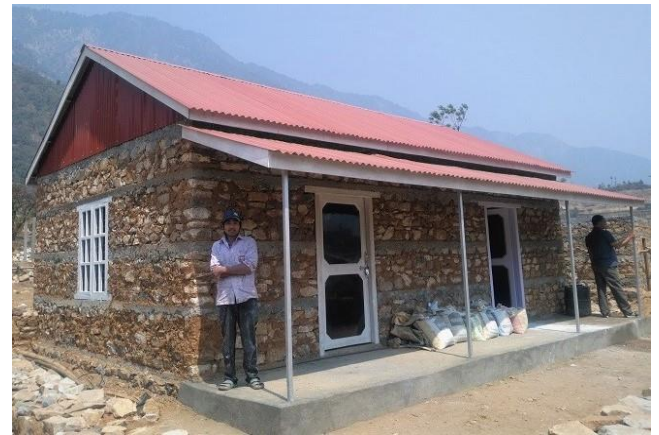
Figure 2: House owner Som Bahadur Ghalng Makwanpur Gadhi Rural Municipality-08. He has been working in reconstruction for 3years as a mason. He received second tranche and verified for third tranche by NRA field base engineer. His house looks attractive and also earthquake resistant like as all horizontal, vertical element provided also light material used. His house is two rooms with one story and total cost of this house is 6lakhs.

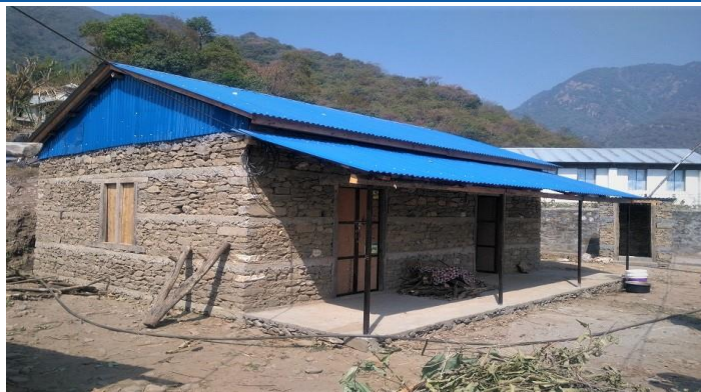
Figure 3: Stone in mud mortar with RCC band, flexible roof and all Horizontal & vertical element provided. House owner received second tranche and verified for third tranche by government engineer. Location of this house is Makwanpur Gadhi-o8 and total cost of this house is around 6lakhs.

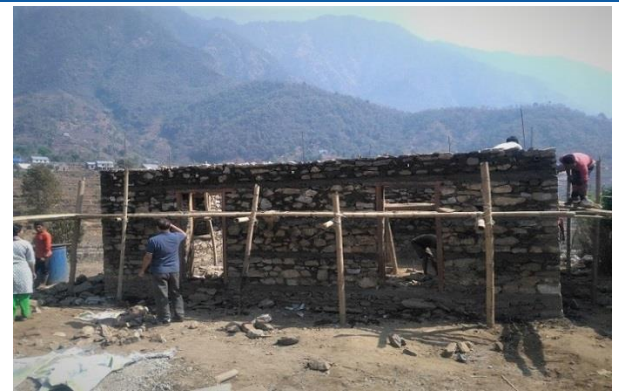
Figure 4: Makwanpur Gadhi Rural Municipality-08, house owner Buddhi Maya Yonjan. Her house is in under construction with stone in mud mortar with RCC band. She has received second tranche.
