District Report

Nuwakot

2 – 8 February 2018

Field Visit Reports

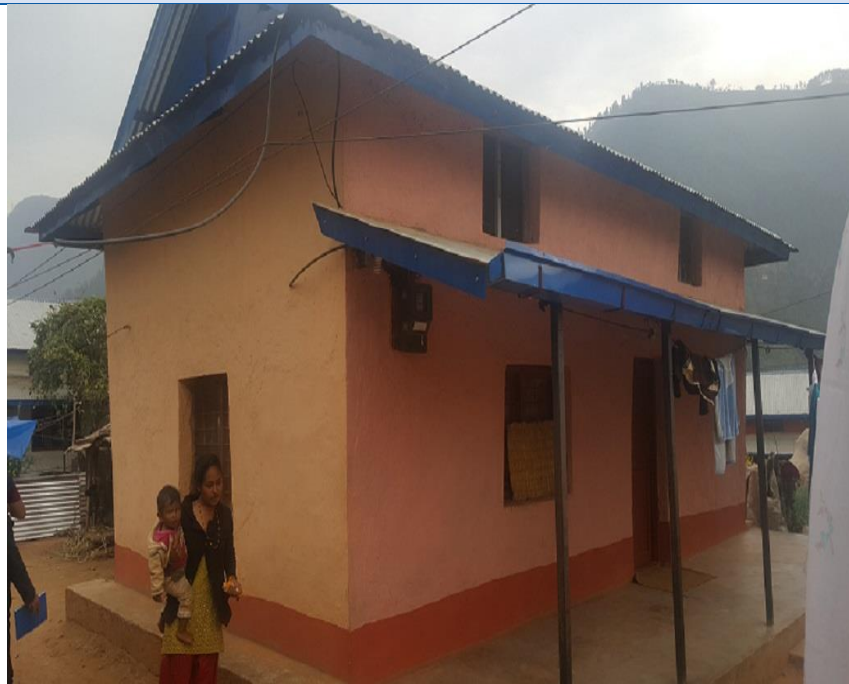
Beneficiary Name: Rita Magranti
Address: Gerkhutar, Bidur - 10
Tranche Status: First Tranche
Housing Structure: **Mud bag** house.
These houses are constructed immediately after emergency relief. There are 18 houses with new techniques of housing with mud bag and already completed but they have not got 2nd and 3rd tranche. They are in the process of getting tranches.
Methodology of making mud bag:
Locally available mud and sand are mixed in certain proportion and packed in a plastic bag.

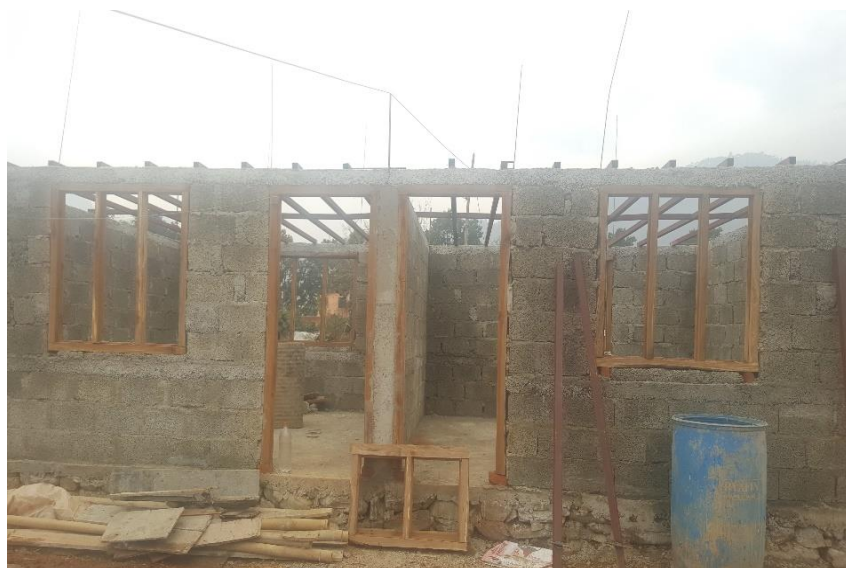
Location: Gerkhutar, Bidur 10
This house is made up of hollow concrete block with 2 rooms but DSE Mr.Saurv said that this is not under compliance due to insufficient vertical reinforcement. Beneficiary is complaining that technical engineers are not coming in right time to inspect.

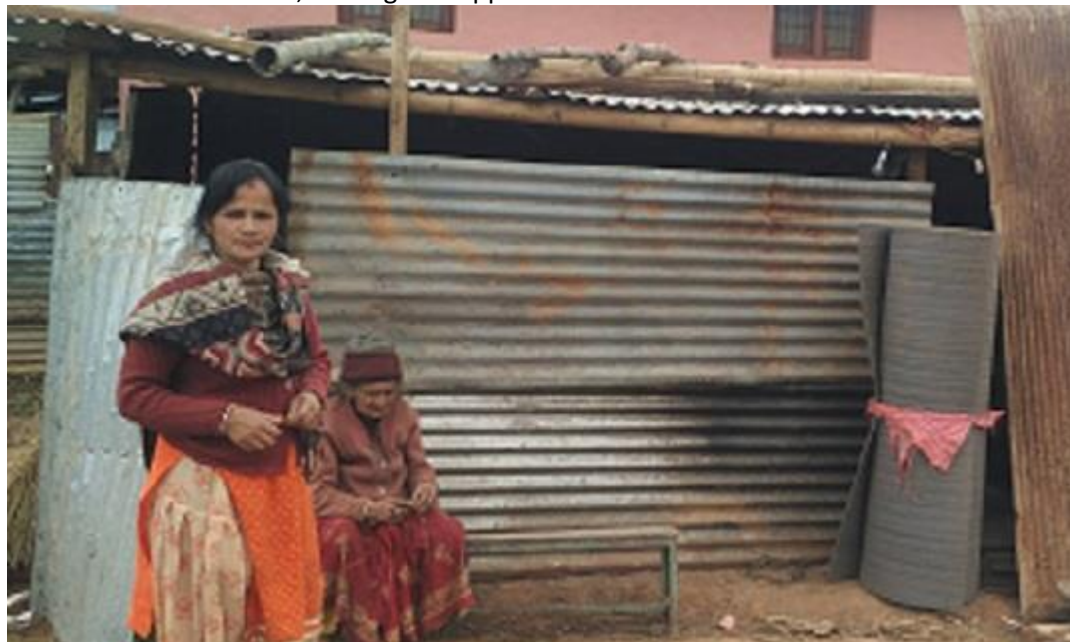
Beneficiary Name: Goma Pudasaini

Location: Gerkhu, Bidur – 10

Tranche Status: First Tranche

She has 3 daughters and one mother. Since earthquake strike, she has been staying in temporary shelter due to loss of her house and she also lost her husband during homewar of Nepal. She is willing to build new house but can not afford therefore, looking for support.
