District Report

Okhaldhunga

19 – 22 February 2018

Housing Typology Report

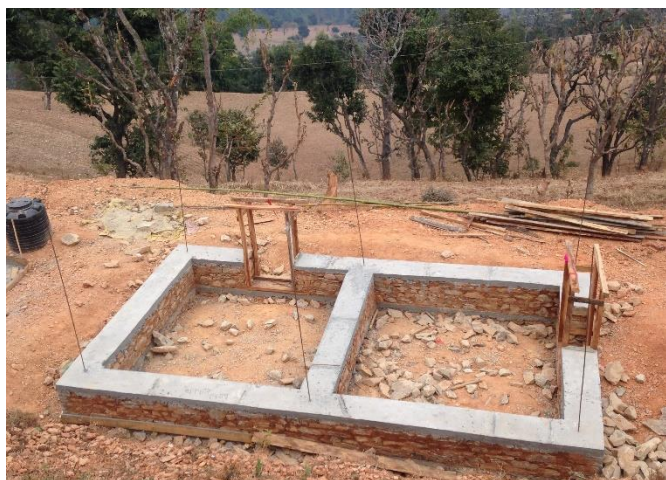
Ward 3, Chishankhu Gadhi Rural municipality, Okhaldhunga: Dhanapati Dhungana is the house owner. He has only received the first tranche and forwarded the file for the second tranche. The stone masonry structure in mud mortar is in progress of rapid construction, some problem on transportation of materials and scarcity of the labor are the main obstacles for the construction said mr. Dhungana.

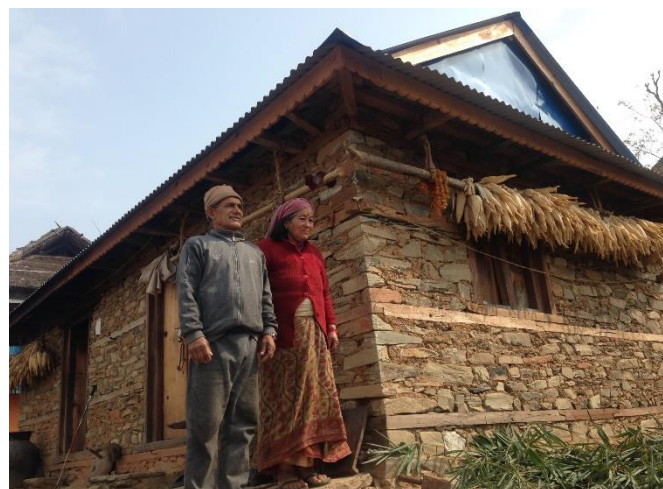
Ward 3, Chishankhu Gadhi Rural municipality, Okhaldhunga : House owner is Dhruyodhan Karki. He has received third tranche. The stone masonry structure with wooden band is the first house constructed in this ward. Mr.Karki is happy with the technical monitoring and guidance provided by the NRA engineer. Only he is afraid on how to protect the wooden band from water and termite. We suggest him to use enamel paints or black tar.

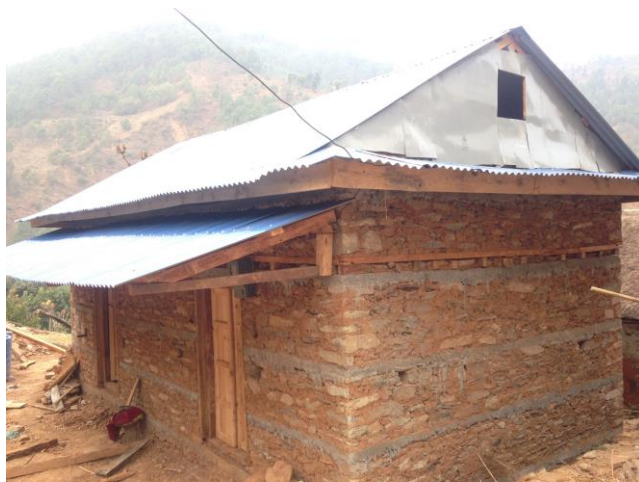
Ward 3, Chishankhu Gadhi Rural municipality, Okhaldhunga: The owner of the house Govinda Parsad Dhungana. The house is almost completed the construction procedure and eligible for the third tranche but he could not even receive second tranche. We asked him why he did not receive the second tranche yet, he said that there is problem in PA number and the name corresponding to the Pa number. The second tranche of Dhungana is transferred to the person Sher bahadur magar who is not a respondent beneficiary to receive the Tranche. Knowing all the problem we transferred this problem to NRA Oghaldhunga for further help

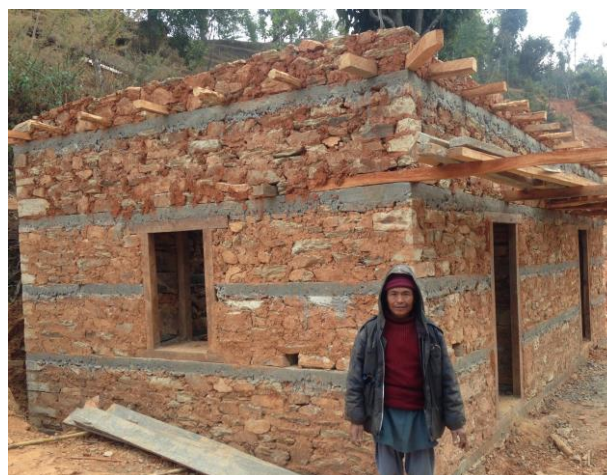
Ward 3, Chishankhu Gadhi Rural municipality, Okhaldhunga: Harka Bahadur Magar is the house owner. He has received Second tranche. The stone masonry structure in mud mortar is in progress of completion and only the roof band is remaining before placing the roof.
