District Report

Ramechhap

19-25 January 2018

Housing Typology Report

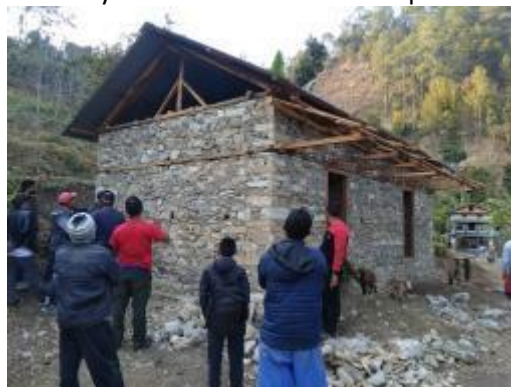
Figure 2. The demo house constructed in Saipu on technical assistance from KAM For SUD Nepal

- The inspection of random rubble masonry with mesh wire conducted in Saipu
The demo house constructed in technical assistance of KAM For SUD Nepal was inspected by DSE, DLPIU Engineer, NRA Engineer, District Technical Coordinator of HRRP and Ward Chairperson of Saipu VDC. The house was constructed as per the design catalogue volume 2 and was constructed by the nominal use of the materials that has to be imported to the working area. The construction technology was checked by DSE and has been proceed for the final verification. The house has been constructed in low cost and other beneficiaries have been attracted by the similar construction practice.

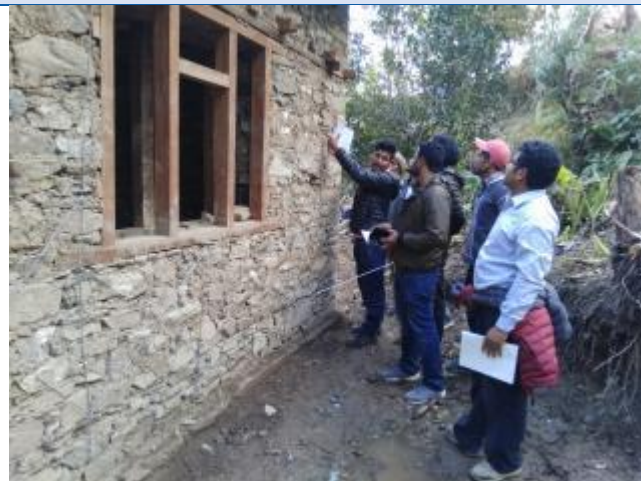
Caption: Inspection of Demo House constructed in technical assistance of KAM For SUD Nepal by DSE, DLPIU and NRA Engineer.

Challenges / Issues Identified	Action Required	Responsible	Timeframe
Scarcity of materials and manpower for the reconstruction in the allocated timeframe.	Needs conditional Extension of time frame	NRA	ASAP
The demo house needs quick approval for other beneficiaries to construct similar house	Review and verify the document for tranche	DSE	ASAP

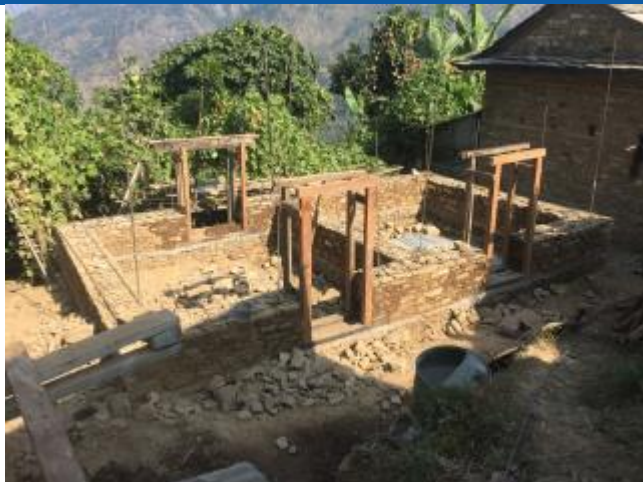
Caption: The house of Bal Krishna Poudel being constructed in Saipu, Likhu Tamakoshi Rural Municipality-2. The owner has received second tranche of reconstruction grant.

- ✓ RC Band Used
- ✓ Stone in mud Mortar
- ✓ Vertical Reinforcement provided

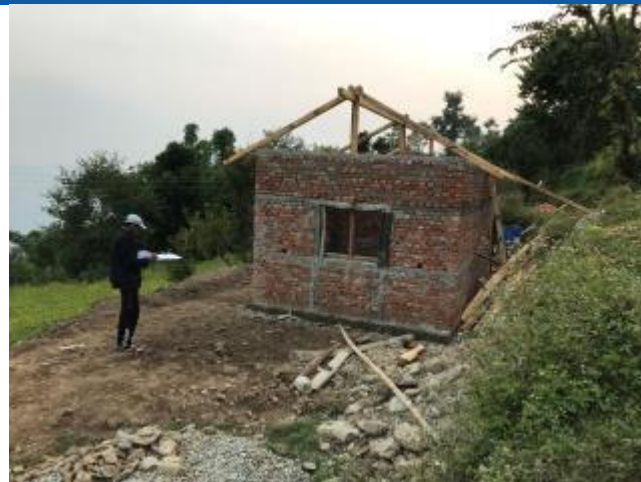
Caption: The house of Naindra Bahadur Sunuwar being constructed in Saipu, Likhu Tamakoshi Rural Municipality-2. The owner has received second tranche of reconstruction grant.

- ✓ RC Band Used
- ✓ Brick in cement Mortar
- ✓ Vertical Reinforcement provided

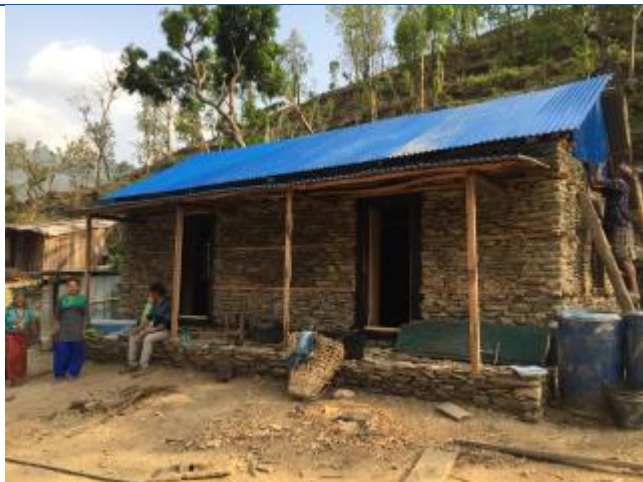
Caption: The house of Chandra Bahadur Magar constructed in Saipu, Likhu Tamakoshi Rural Municipality-2. The owner has received second tranche of reconstruction grant and has been forwarded for third tranche.

- ✓ Wooden Band Used
- ✓ Stone in mud Mortar
- ✓ Vertical Reinforcement provided
- ✓ Flexible and light roof provided

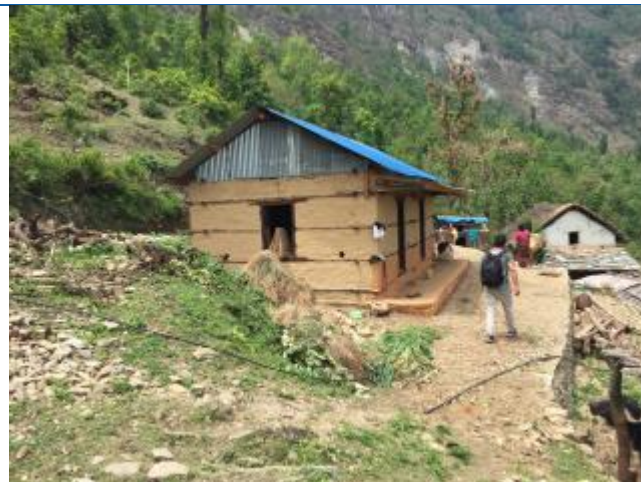
Caption: The house of Rama Bhujel constructed in Saipu, Likhu Tamakoshi Rural Municipality-2. The owner has received second tranche of reconstruction grant and has been forwarded for third tranche.

- ✓ Wooden Band Used
- ✓ Stone in mud Mortar
- ✓ Vertical Reinforcement provided
- ✓ Flexible and light roof provided

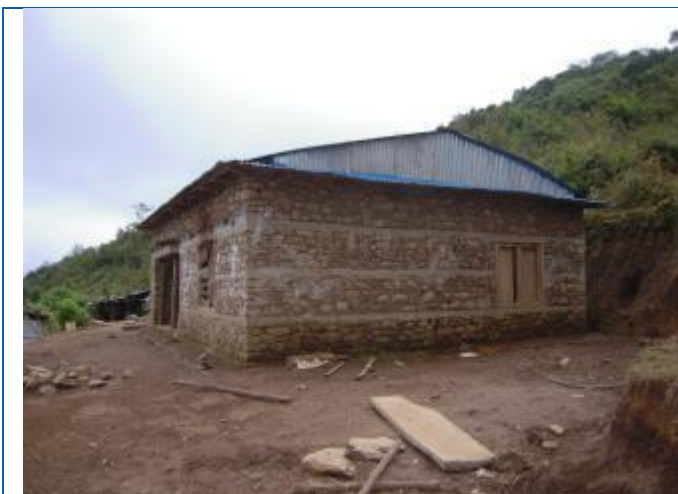
Caption: The house of Devi Dhoj Karki constructed in Saipu, Likhu Tamakoshi Rural Municipality-2. The owner has received second tranche of reconstruction grant and has been forwarded for third tranche.

- ✓ RC Band Used
- ✓ Stone in mud Mortar
- ✓ Flexible and light roof provided

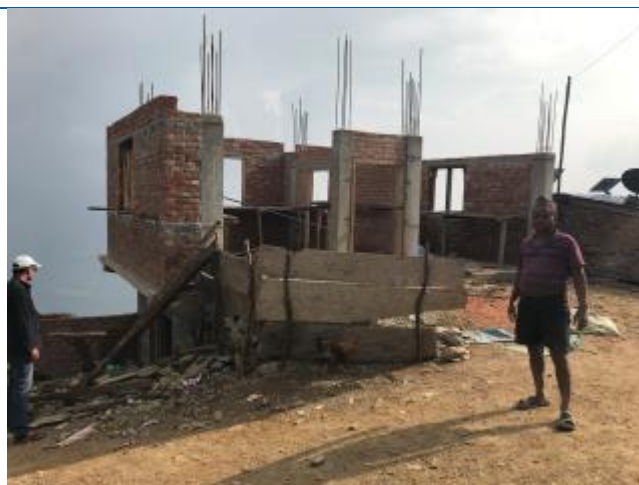
Caption: The house of Raju Dilauri being constructed in Saipu, Likhu Tamakoshi Rural Municipality-2. The owner has received first tranche of reconstruction grant.

- ✓ All bands provided
- ✓ Brick in cement mortar
- ✓ Appropriate size of column and beam
- ✓ One bay in one direction

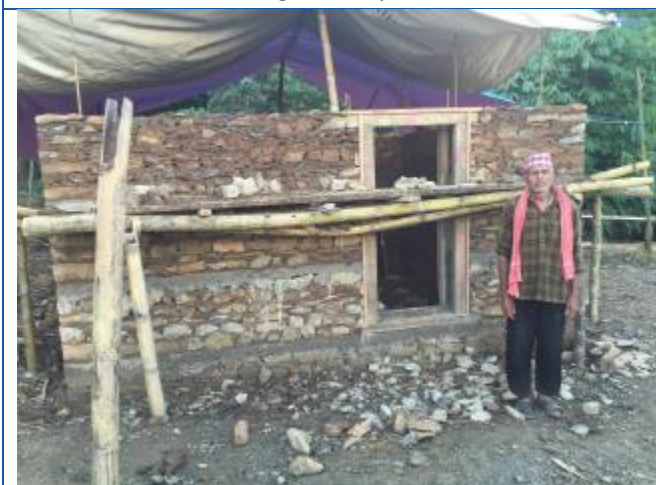
Caption: The house of Shiva Prasad Gautam being constructed in Saipu, Likhu Tamakoshi Rural Municipality-2. The owner has received second tranche of reconstruction grant.

- ✓ RC Band Used
- ✓ Stone in mud Mortar
- ✓ Vertical Reinforcement provided

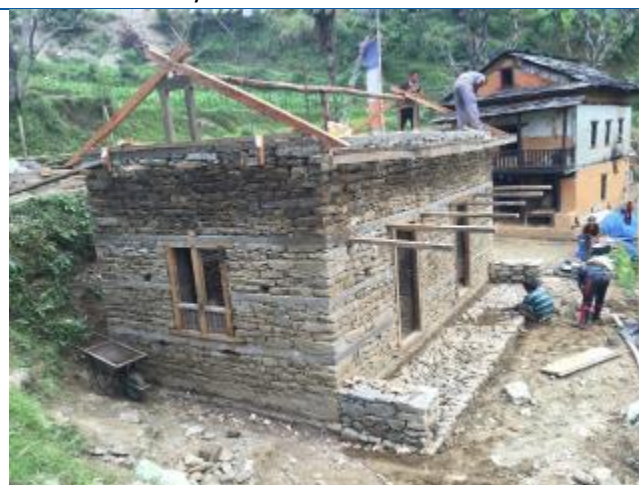
Caption: The house of Hom Bahadur Tamang being constructed in Saipu, Likhu Tamakoshi Rural Municipality-2. The owner has received second tranche of reconstruction grant.

- ✓ RC Band Used
- ✓ Stone in mud Mortar
- ✓ Vertical Reinforcement provided
