District Report

Makwanpur

27 April to 3 May 2018

Field Visit Reports

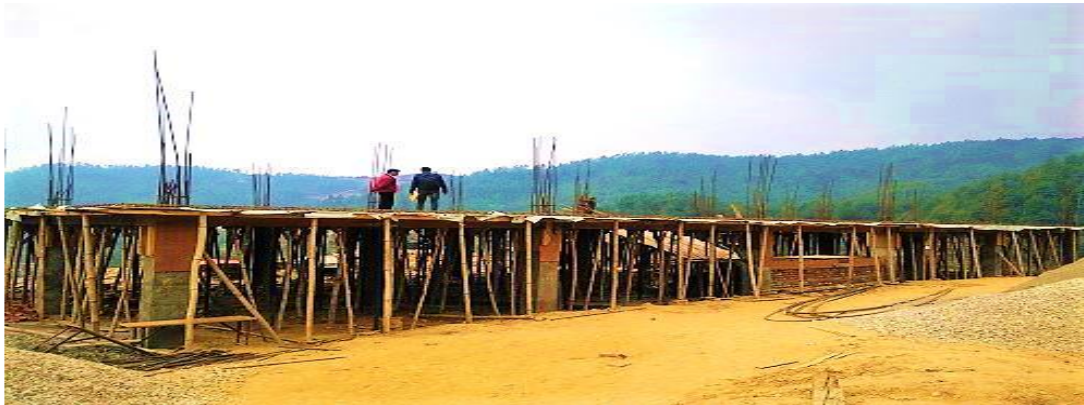
<p>Figure 1: Indrasarowar Rural Municipality -05, Mahachuli Higher secondary school, under construction school building, fund supported by Plan International Nepal and implementing partner is RADO Nepal. Total 8rooms, two story with rigid roof. Reinforcement bar layout with first floor for 4rooms.</p> <p>We briefed discussed about the agendas of overall reconstruction status, major key issues and challenges, POs activities, coordination between beneficiaries and technicians, role of ward members in their locally level.</p> <p>We found out some issues like as shortage of skilled manpower, water problem in some places, payment rate is high for skilled manpower etc. Mobilization of technicians, inspection rate is good in now days. The concluded point after meeting is inspection file submit within 7days, if beneficiaries completed to roof band level and repaired/constructed toilet work early inspection and maintain to tranches gap and at ending of month, reconstruction meeting conduct in ward office with present of technicians and ward members.</p> <p>Current reconstruction rate is here, Indrasarowar Rural Municipality.</p>

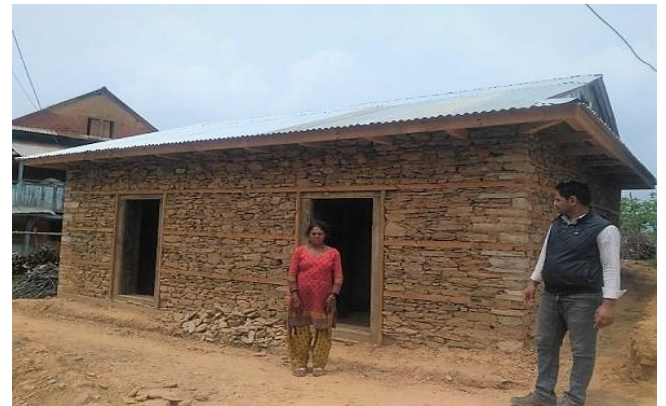
Figure 3: Indrasarowar Rural Municipality-01, house owner Nar Bahadur Bist. Stone in mud mortar with timber band and flexible roof. He has received all tranches of government grant. The tentative construction cost of this building is 5lakh..

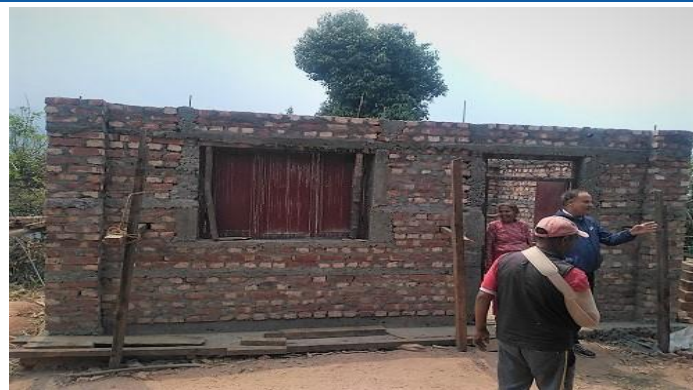
Figure 3: Indrasarowar-01, house owner: Govind Bahadur Bist, under construction brick in cement mortar with RCC band with vertical and horizontal elements. Verified for second tranche by NRA engineer.

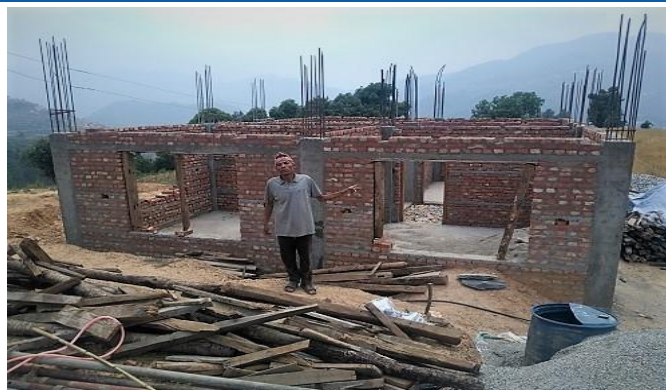
Figure 4: RCC frame structure with meet all mandatory requirement Thumb rule. His house verified for second tranche and the location of building is Indrasarowar-01, house owner name is Ram Sharan Bist.
